Test Report 测试报告

Qualification of a Solar Collector in accordance with
太阳能集热器的测试参照标准
EN12975-1:2006+A1:2010 and ISO 9806: 2017

TÜV 报告编号: 50152941-001

Qualification of a Solar Collector in accordance with
EN12975-1:2006+A1:2010 and ISO 9806: 2017

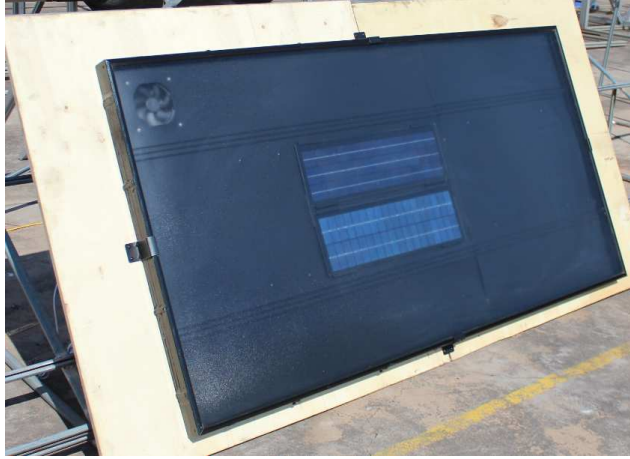
Fig. 5: incoming inspection
图 5: 初检

Date 日期	2018-01-29	Tester 测试员	Jinping Yang
Internal barcode no. 内部编号	Serial no. 序列号	Description of defects 缺陷描述	
A000689745-001	OS42-20180109-009	No visual damages	
A000689744-001	OS22-20180109-007	No visual damages	
A000689744-002	OS42-20180109-003	No visual damages

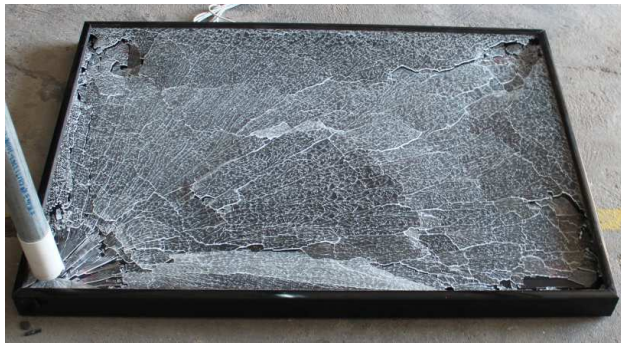
Fig. 7: impact testing
图 7: 撞击测试

During the steel ball impact test, the glass cover broken detected when the vertical height increased to 1.4m.

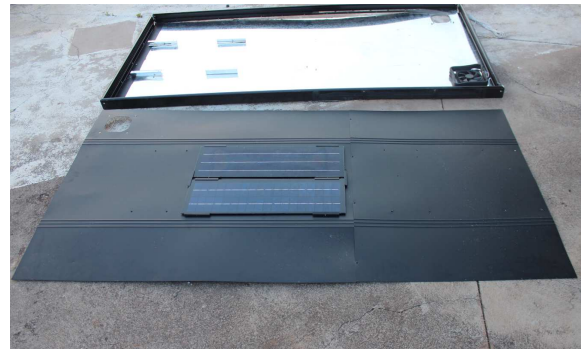
Fig. 8: final inspection
图 8: 终检

Collector component 集热器部件	Potential problem 潜在问题	Evaluation 评价
a)	Collector box, fasteners 集热器联箱、紧固件	Cracking, warping, corrosion, rain penetration 破裂、弯曲、腐蚀、渗水	0
b)	Mountings, structure 支架、结构	Strength, safety 强度、安全性	0
c)	Seals, gaskets 密封、垫圈	Cracking, adhesion, elasticity 破裂、粘附、弹性	0
d)	Cover, reflector 盖板、反光板	Cracking, crazing, buckling, delamination, warping, out gassing 破裂、碎裂、屈曲、分层、扭曲、漏气	1
e)	Absorber coating 吸热体涂层	Cracking, crazing, blistering 破裂、碎裂、起泡	0
	Absorber tubes and headers 吸热管和管头	Deformation, corrosion, leakage, loss of bonding 变形、腐蚀、泄露、失去粘合	0
	Absorber mounting 吸热体安装	Deformation, corrosion 变形、腐蚀	0
f)	Insulation 保温材料	Water retention, out gassing, degradation 渗水、外漏、退化	0

Height 1.4m of the 150g steel ball impact cause glass cover broken.
Negative 1936Pa cause the glass cover broken.
